Radiator upgrade

While my bike was apart for repairs I decided to see if I could fit the larger 2006-later fans to my 2002. When I ordered Honda repair parts I also ordered larger radiators.

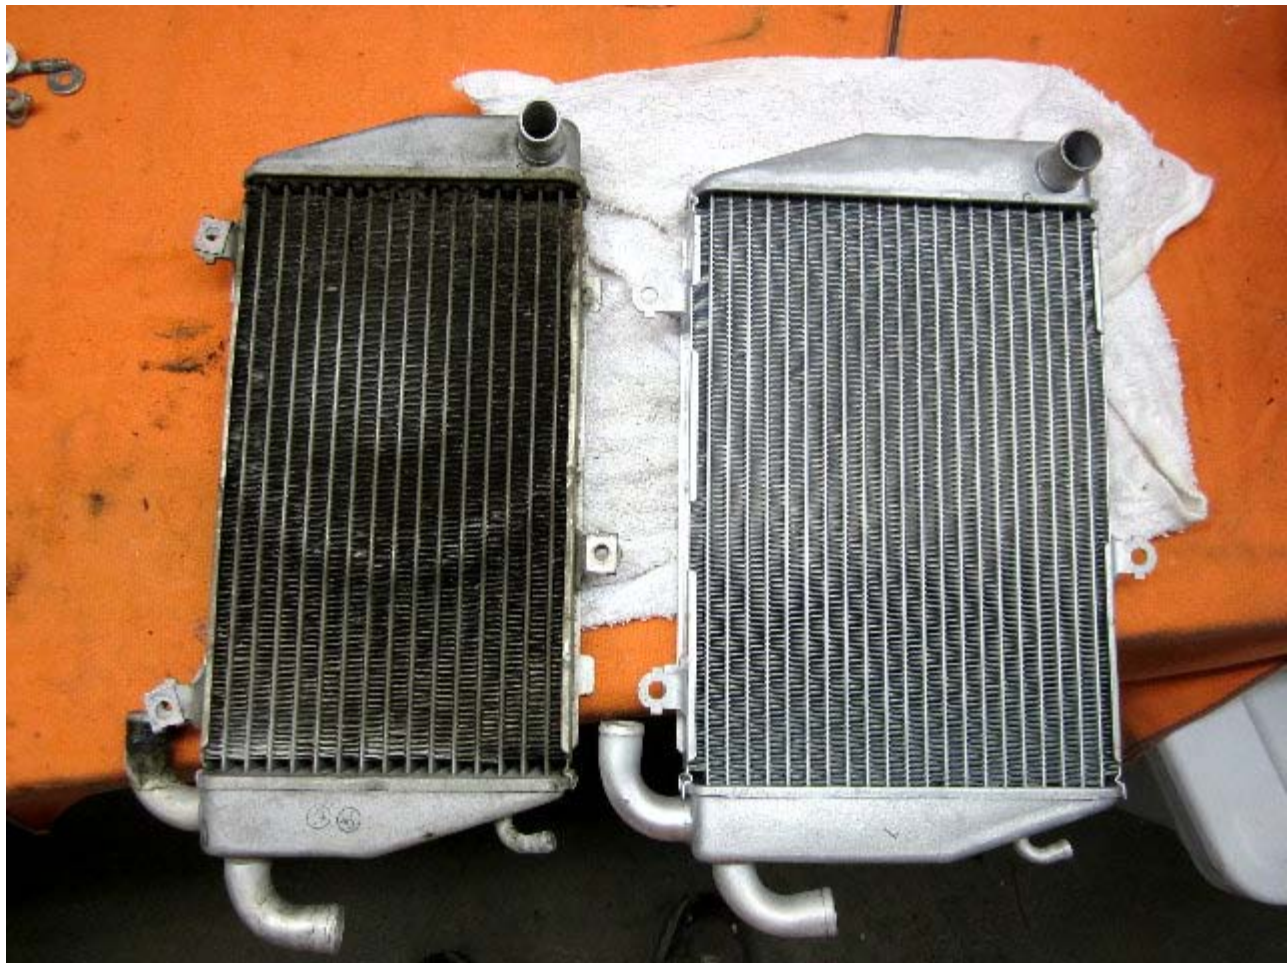
I wasn't sure how much bigger the new radiators would be but they are noticeably bigger...a little over 30% to be exact. The core is 1 1/4" taller...

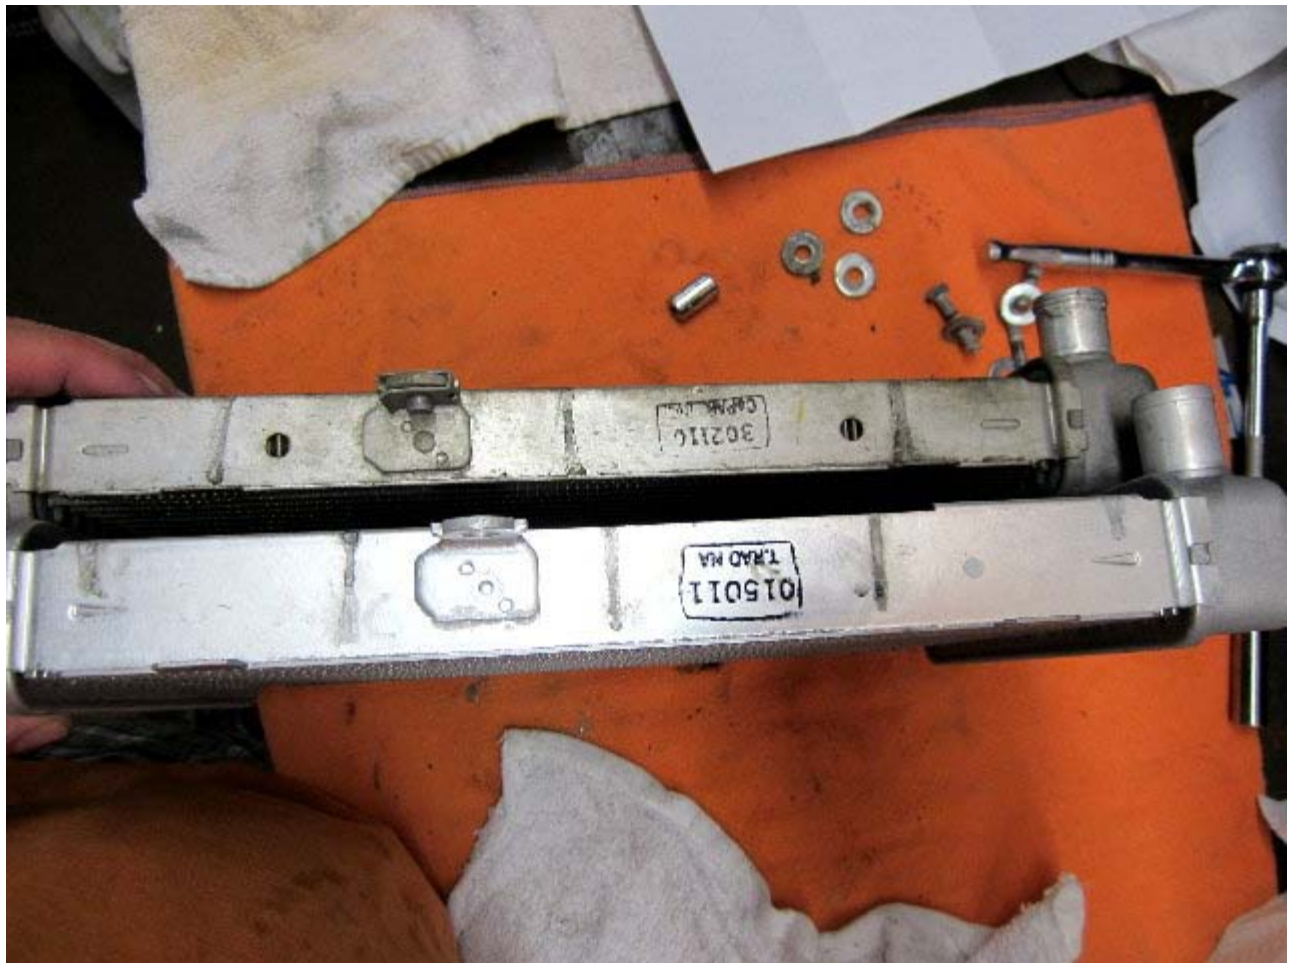
...and an 1/8" thicker.

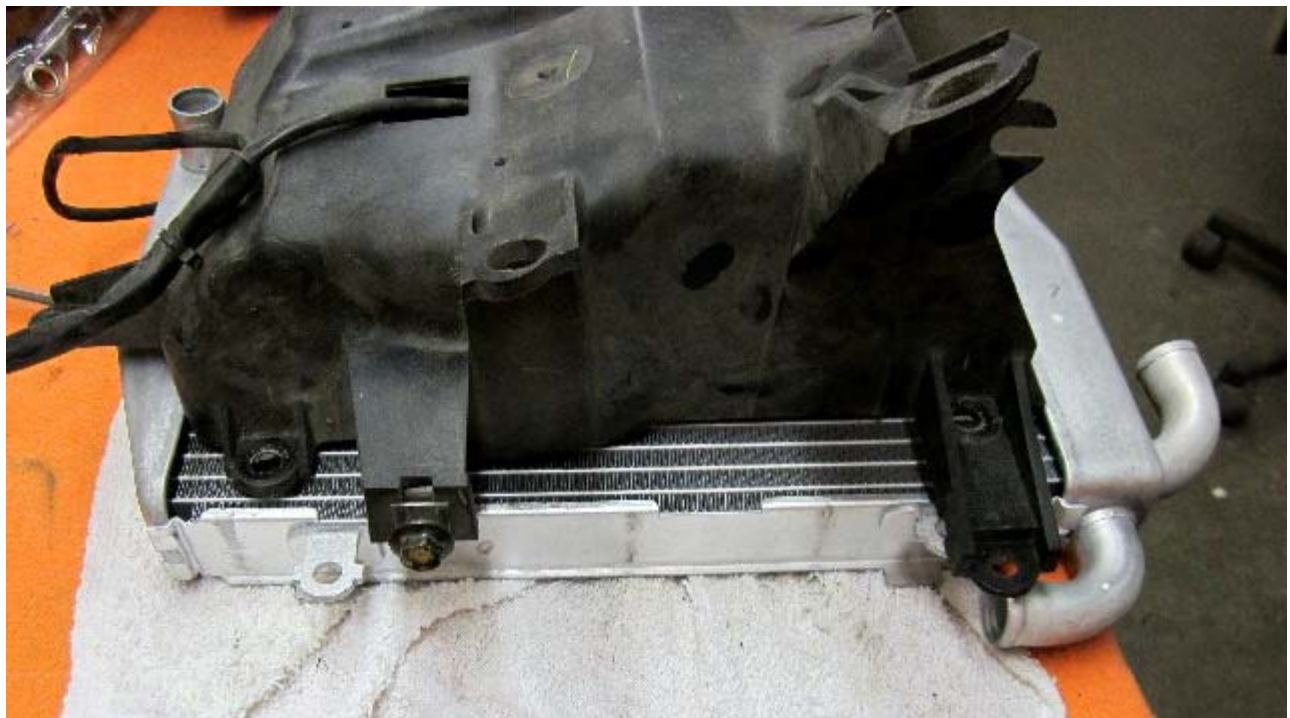
It didn't take much piddling to see the new radiators wouldn't work with the stock shrouds...

... so I ordered new shrouds (left) and [screens](#).

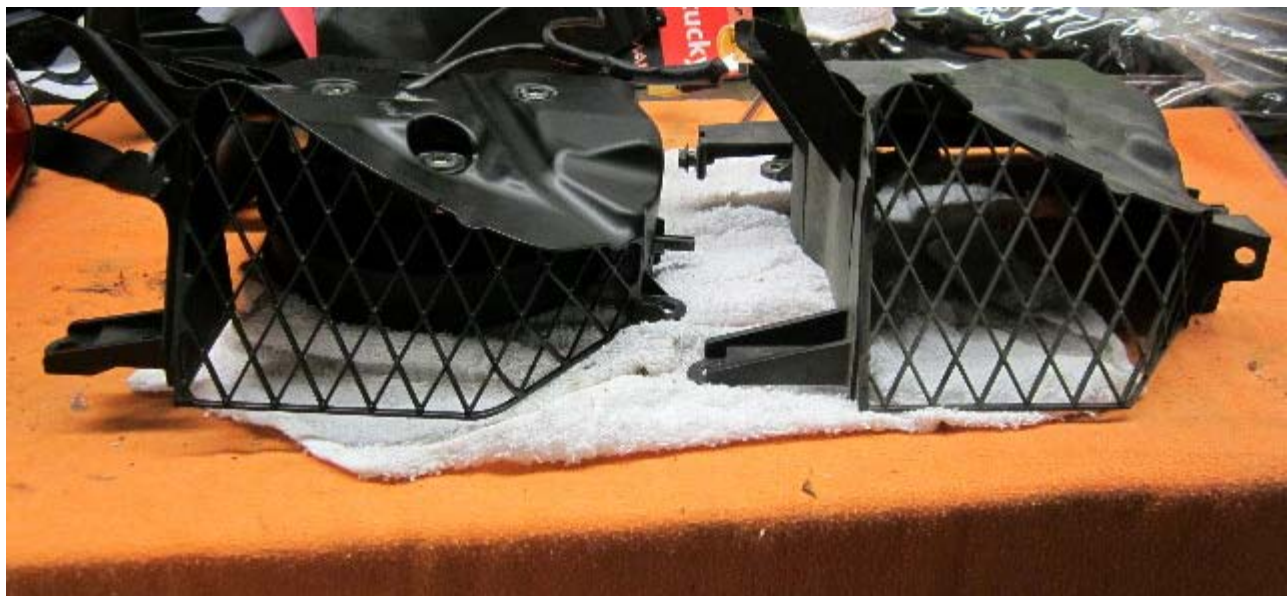
The newer shrouds have larger air openings as well.

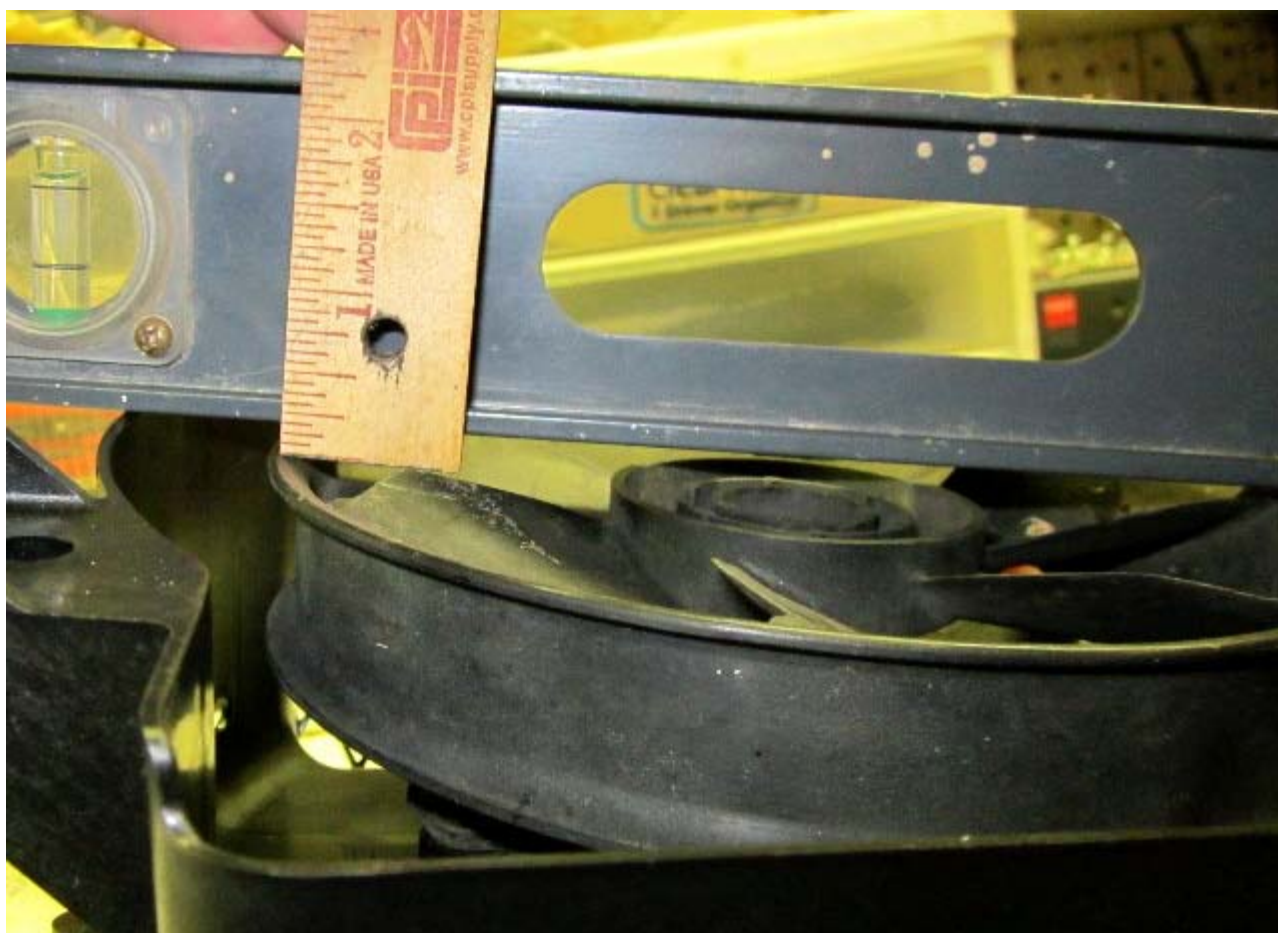
I was concerned how much fabrication would be involved in getting everything together. I was pleased to find the old motors bolted right into the new shrouds. The (reversed) fan assembly was about 3/16" away from the plane of the shroud.

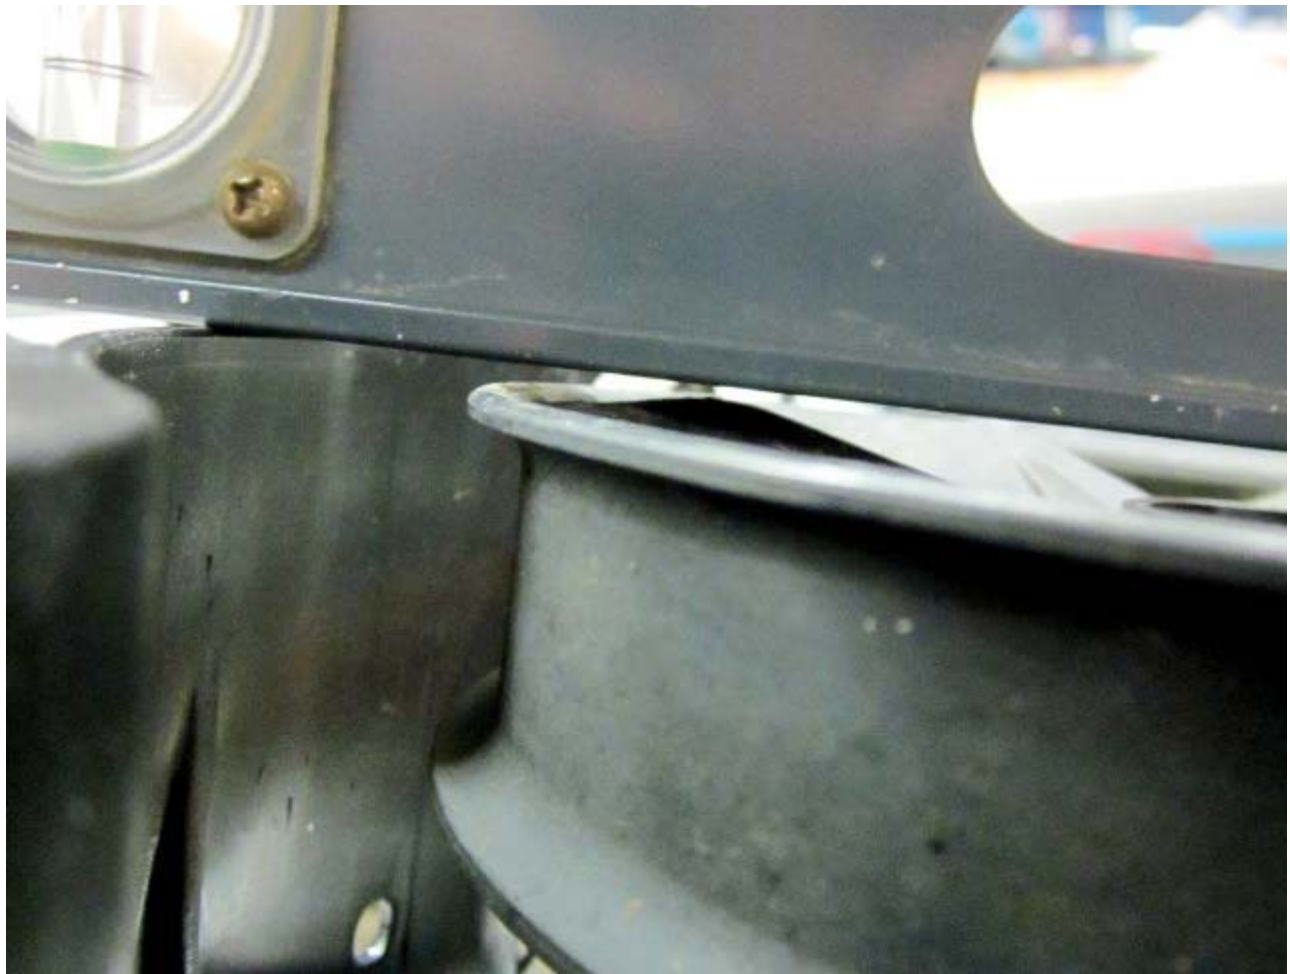
I used a washer per fan mounting bolt to space the assembly closer. Two washers caused the fan assembly to rub the radiator.

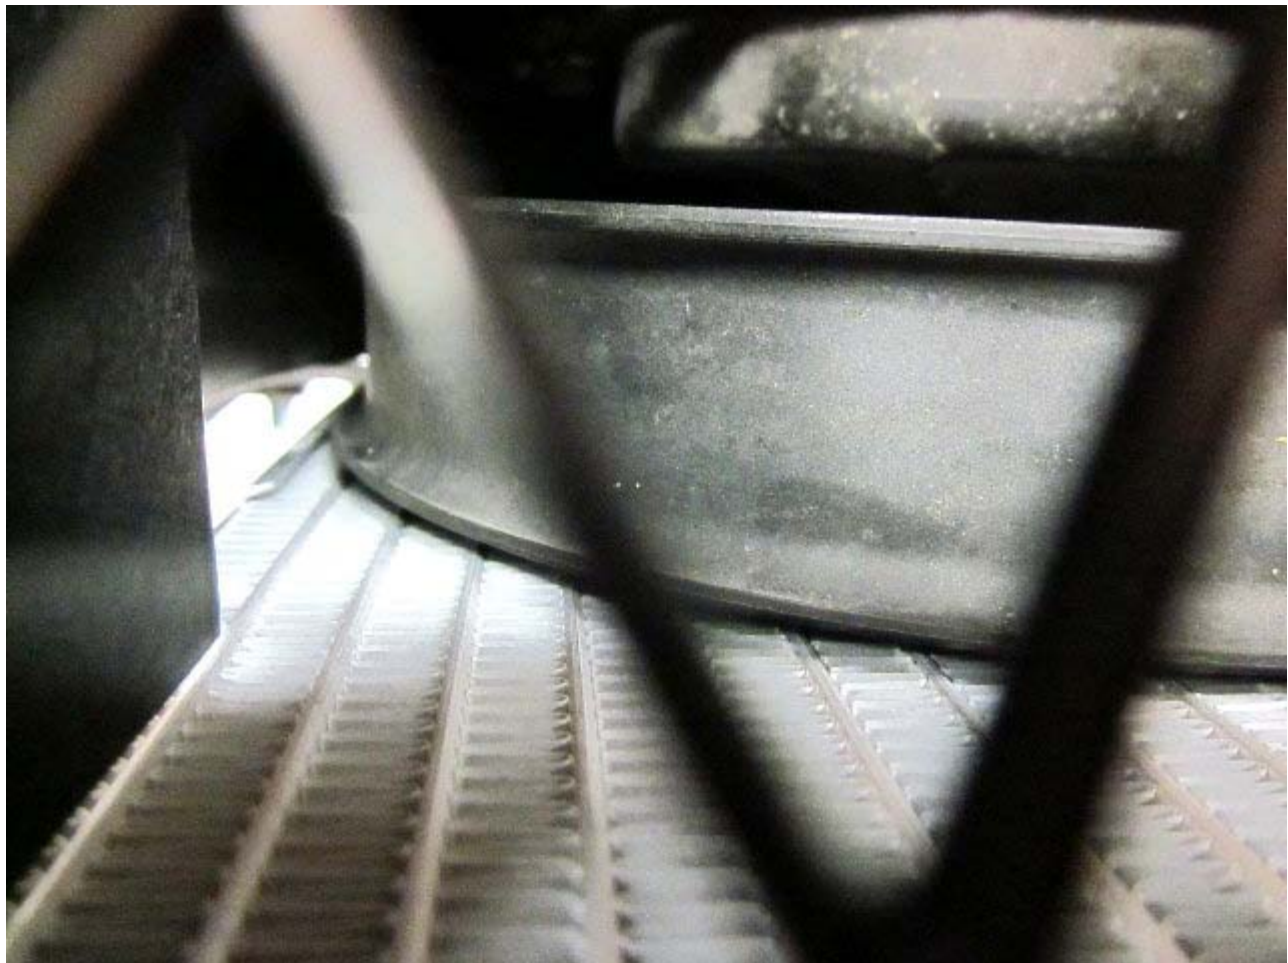
Here is the clearance with one washer spacing the fan motor.

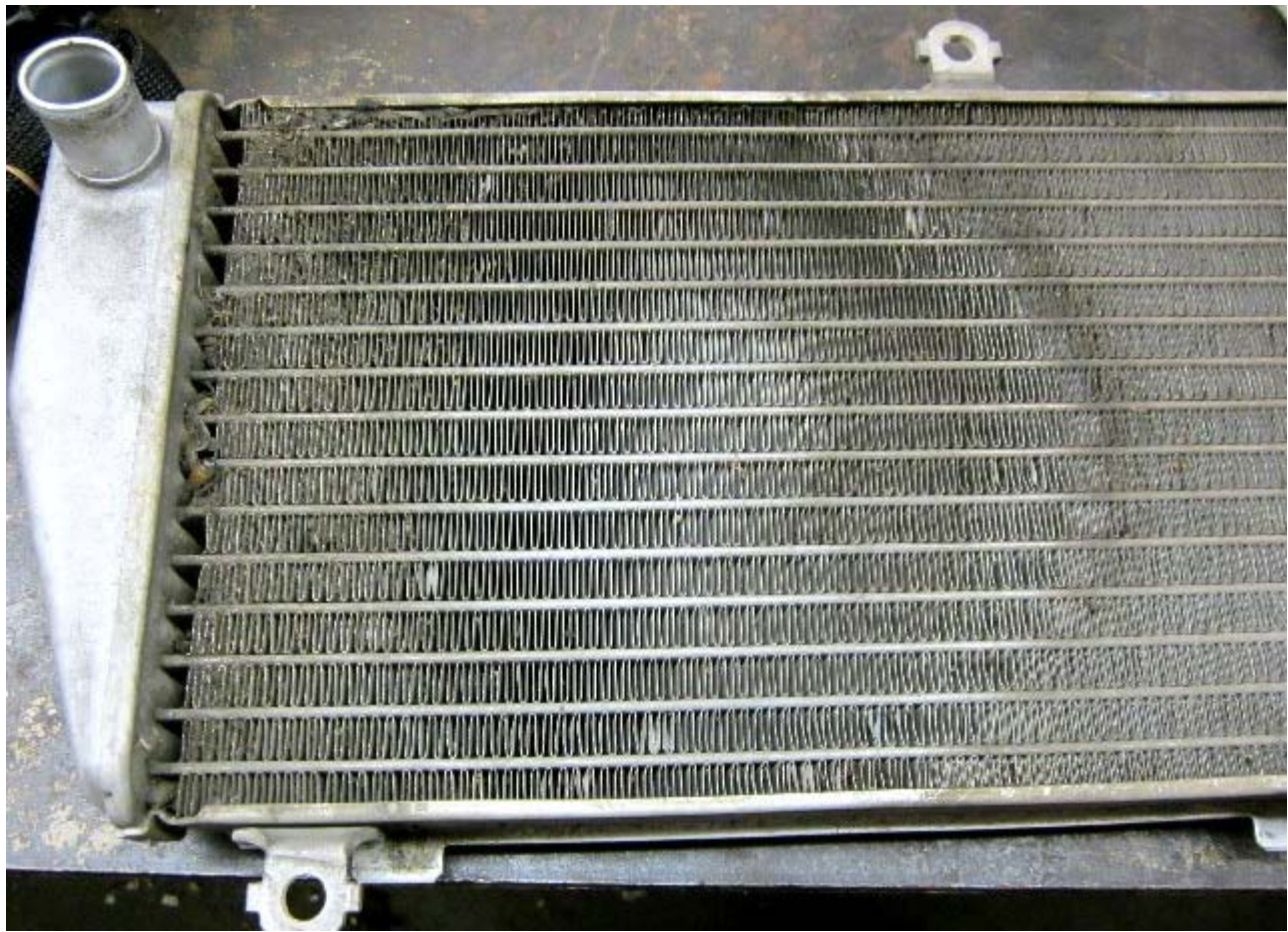
As can be seen by the old radiator the fan overlaps the radiator. On the new radiator the entire fan blows through the radiator.

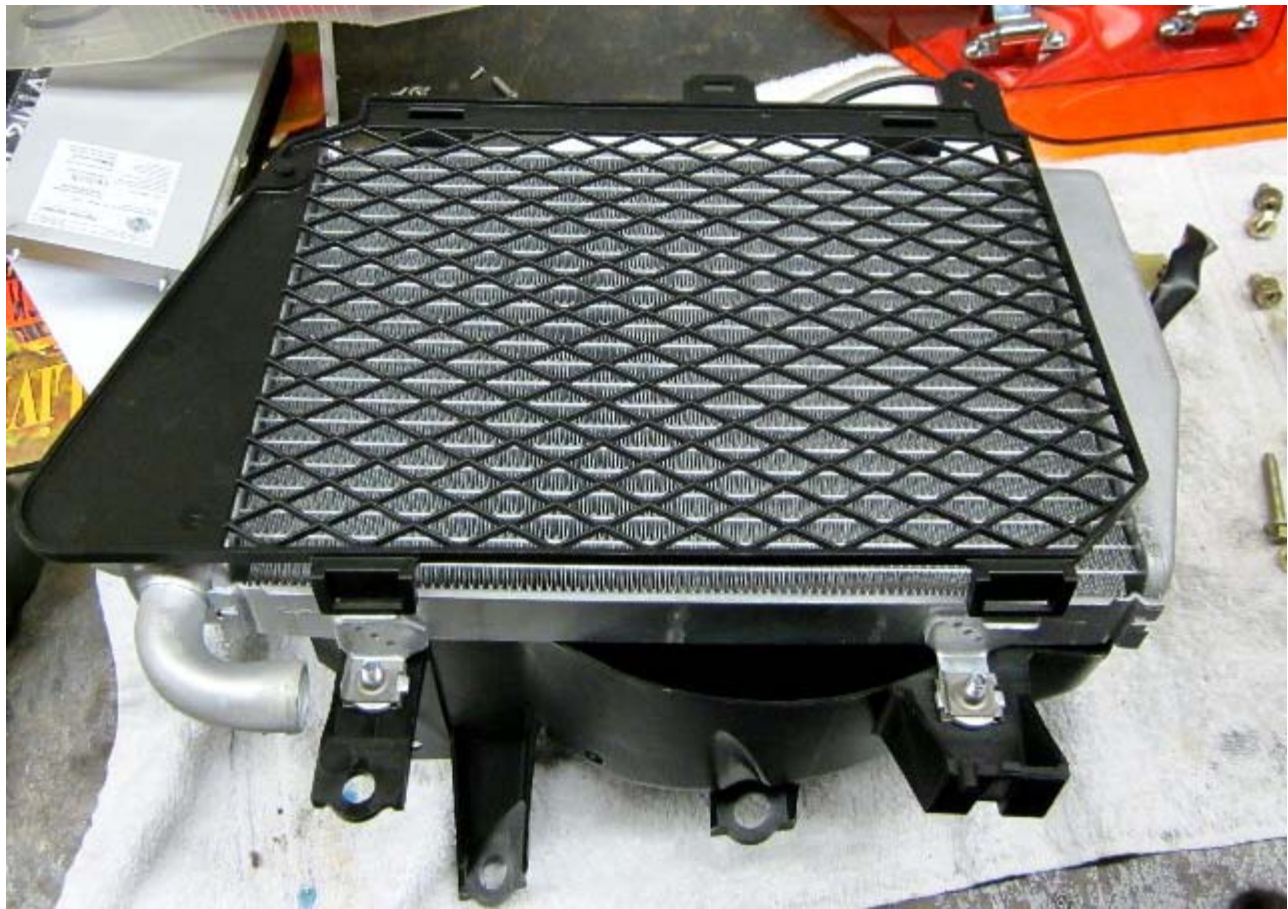
Here is the new radiator/new shroud/old fan assembly.

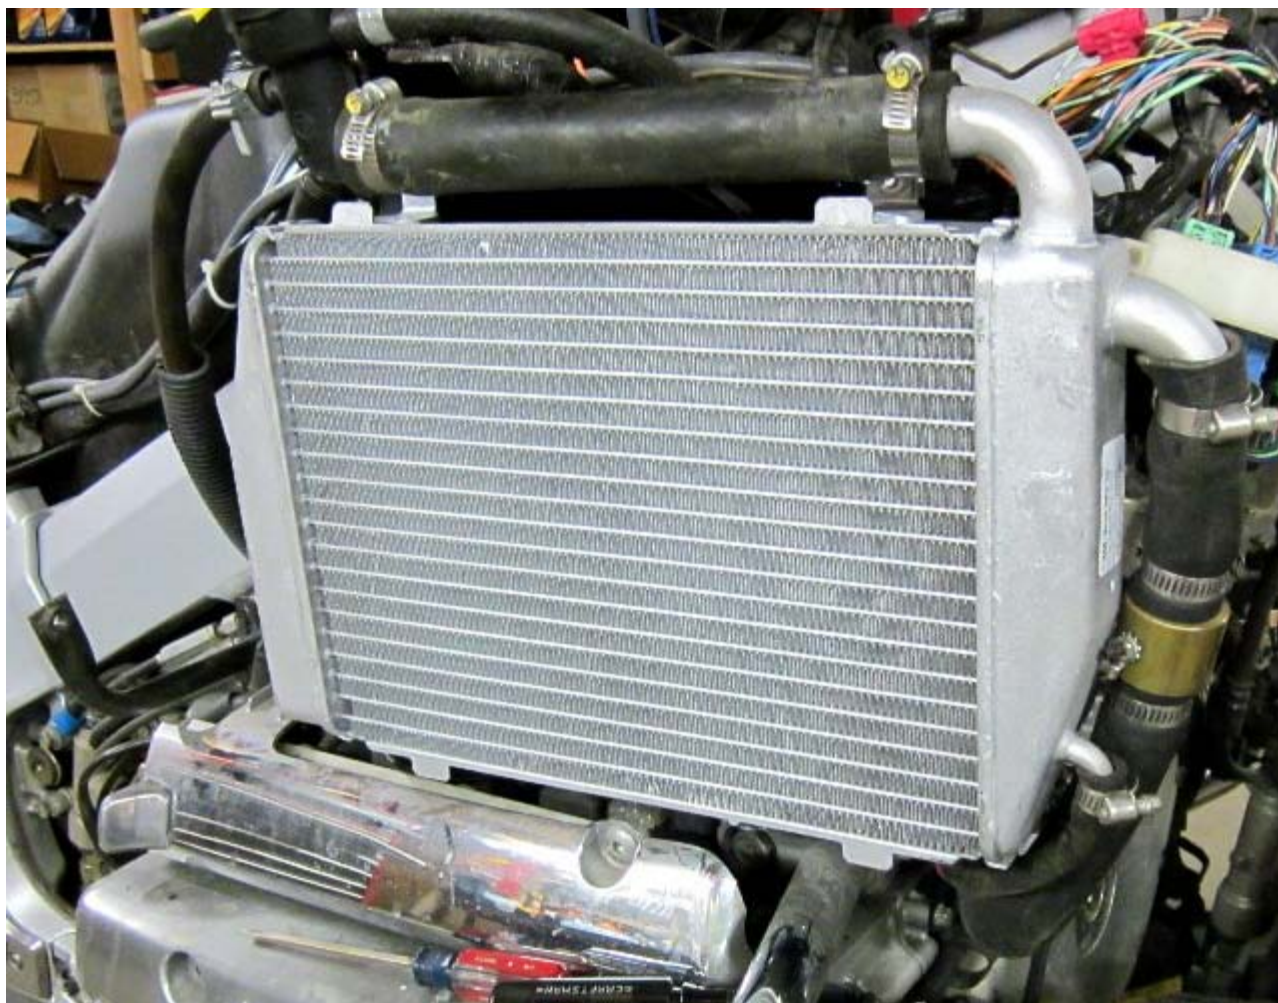
It was unknown if the new shrouds would use the old frame mounting holes, but they did! Here the right radiator is installed.

NOTE: I got rid of the worthless plastic vent tubes years ago. The larger radiators won't fit with the vent tubes.

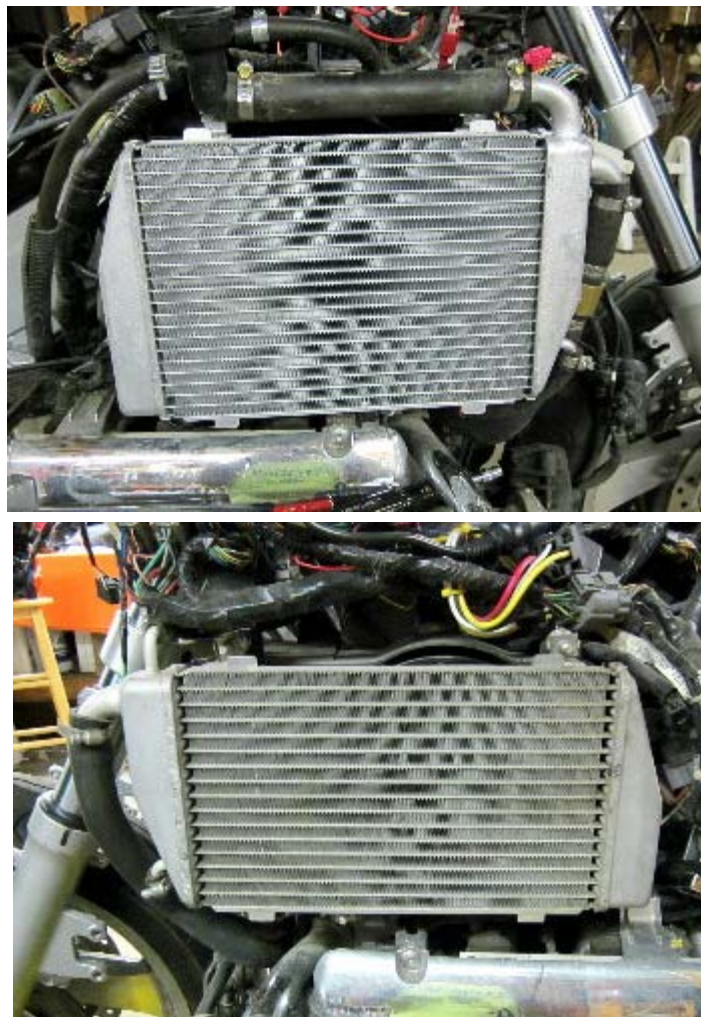
Comparison of the new and old radiator size.

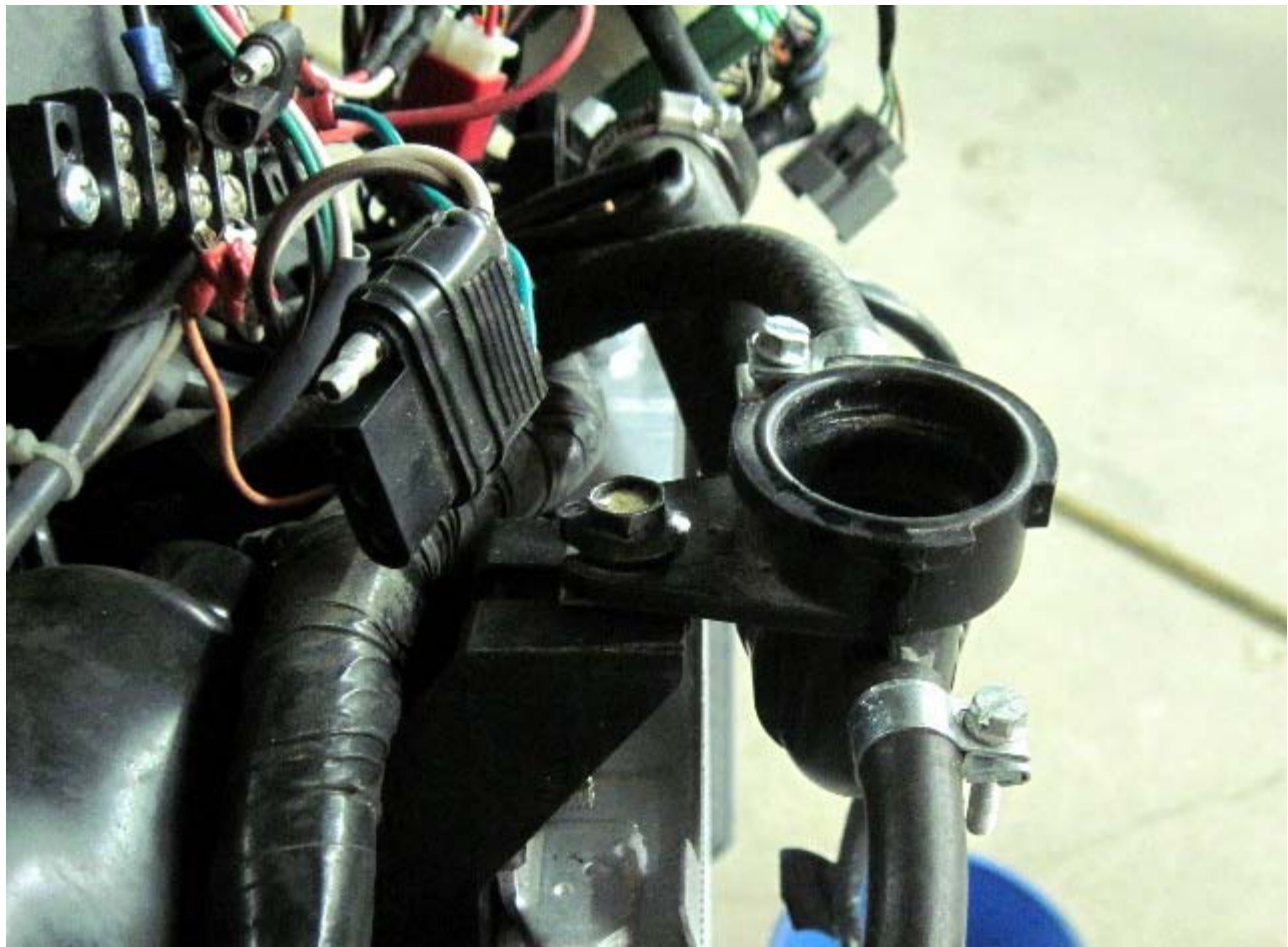
The filler neck didn't look right. It stuck out and there's no way the front fairing would fit with it like that. A check of the parts fiche revealed the newer bikes have a different neck so I ordered one.

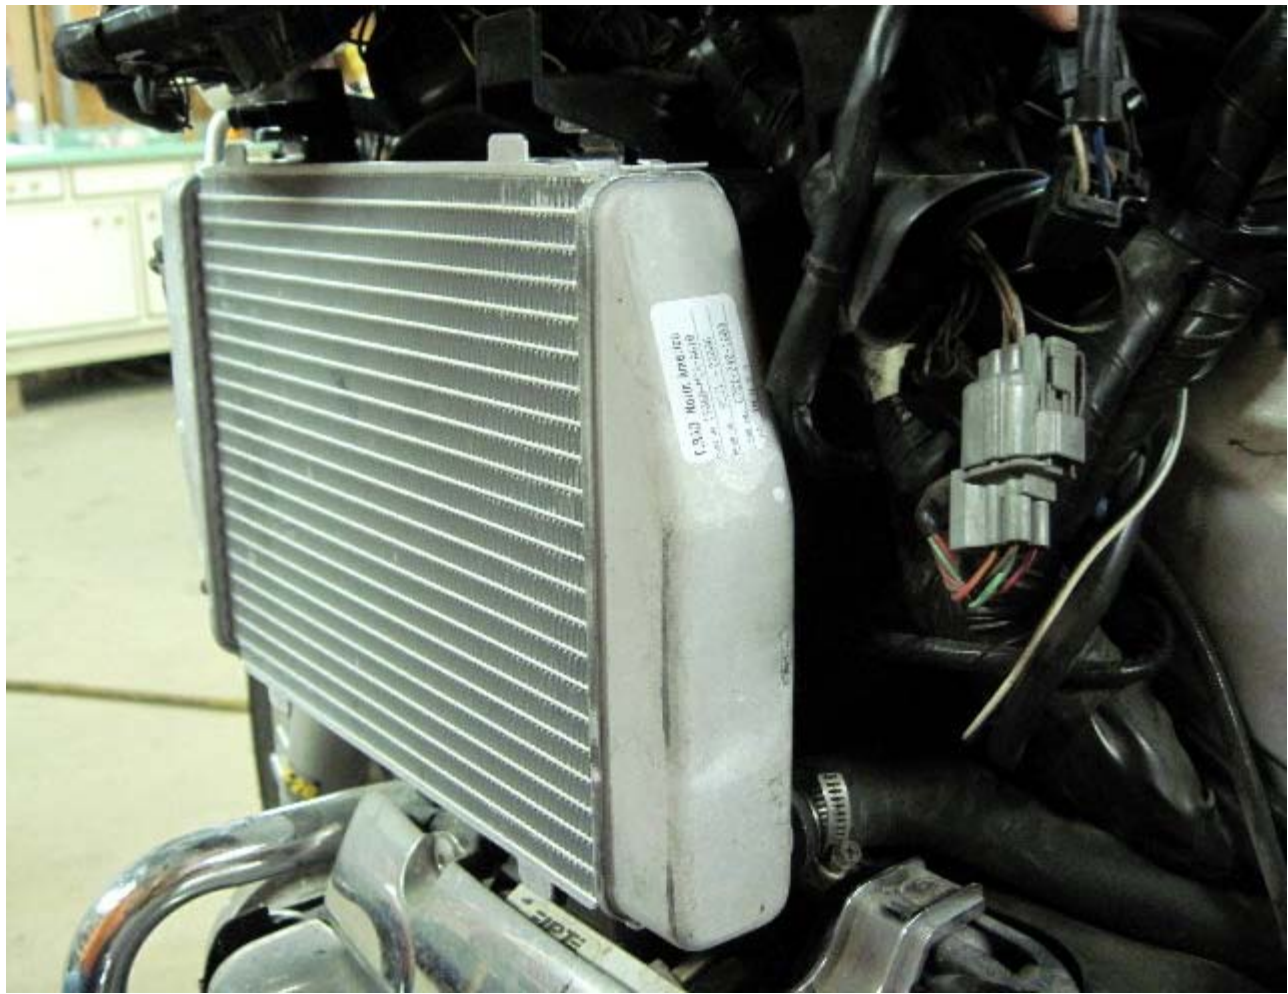
The left radiator installed.

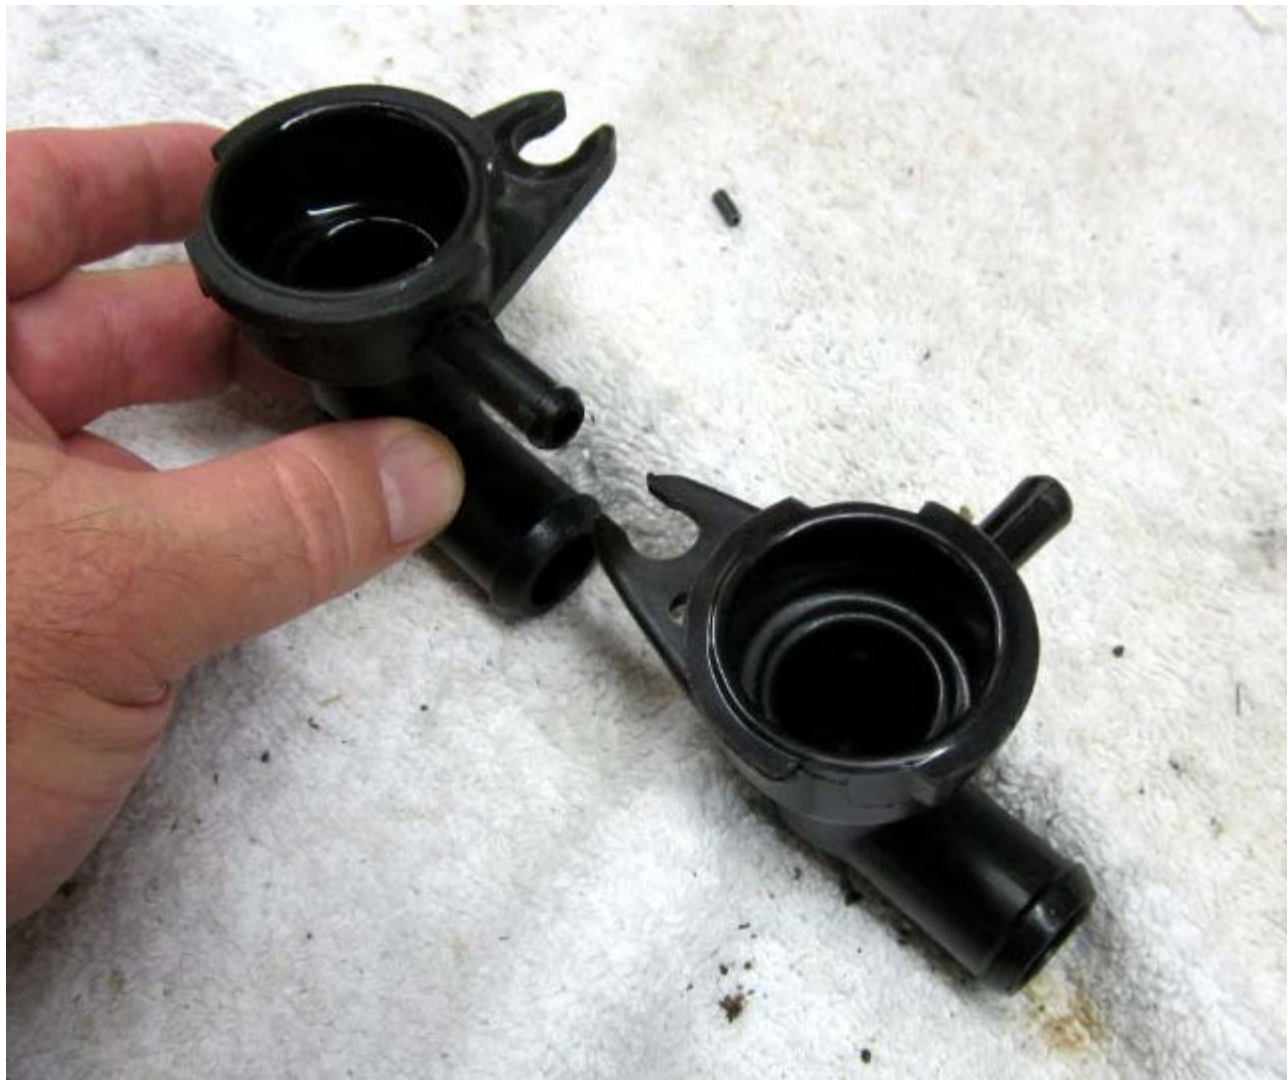
The new neck is oriented differently and is [shorter](#).

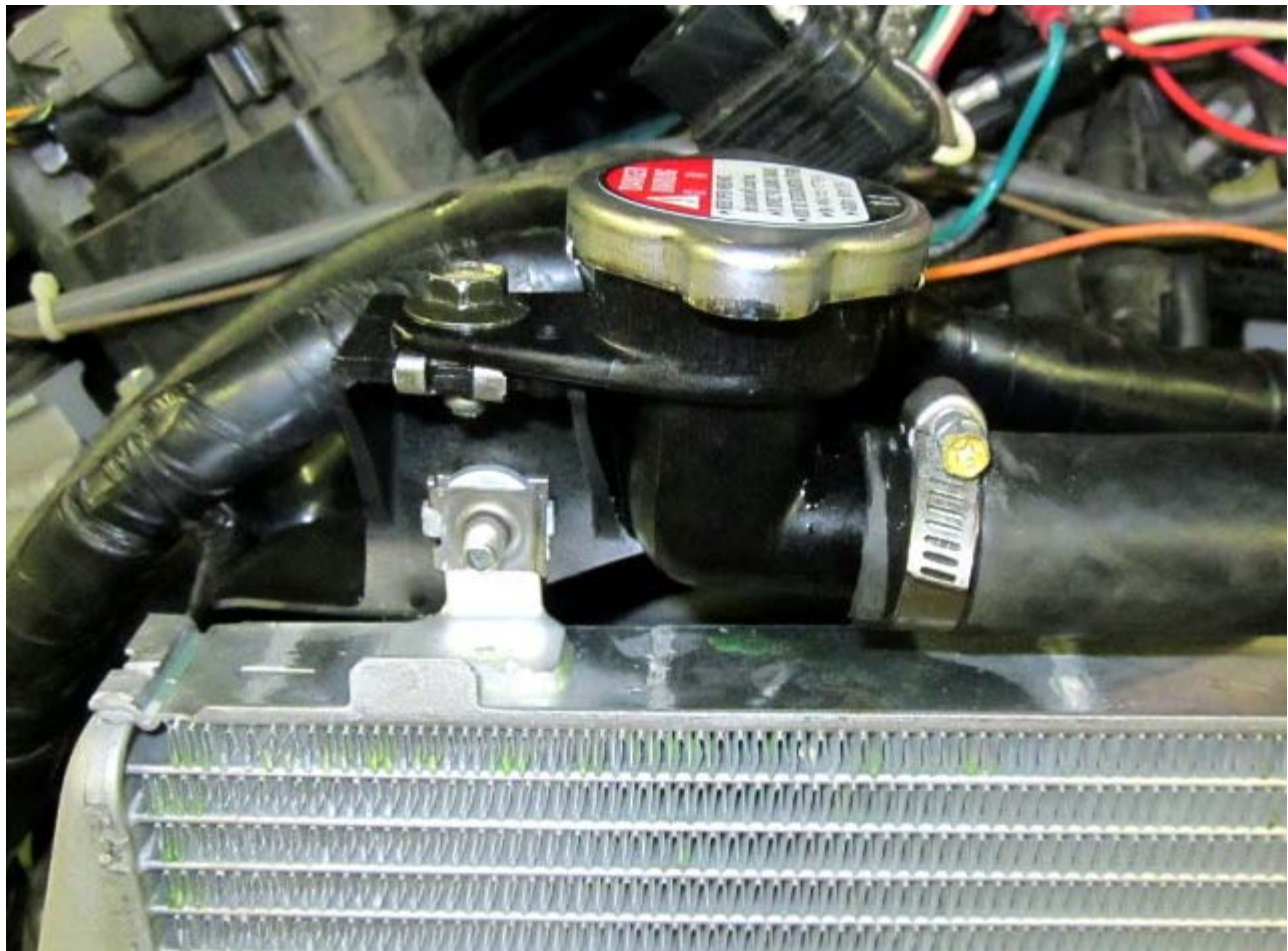
The new filler neck in place. The two nipples for the crossover hose and overflow tank hose point inwards and makes more sense than the previous filler neck.

Note the antifreeze drops on the radiator...I overfilled it as I seem to do every time. Makes the bike stink of antifreeze for awhile.

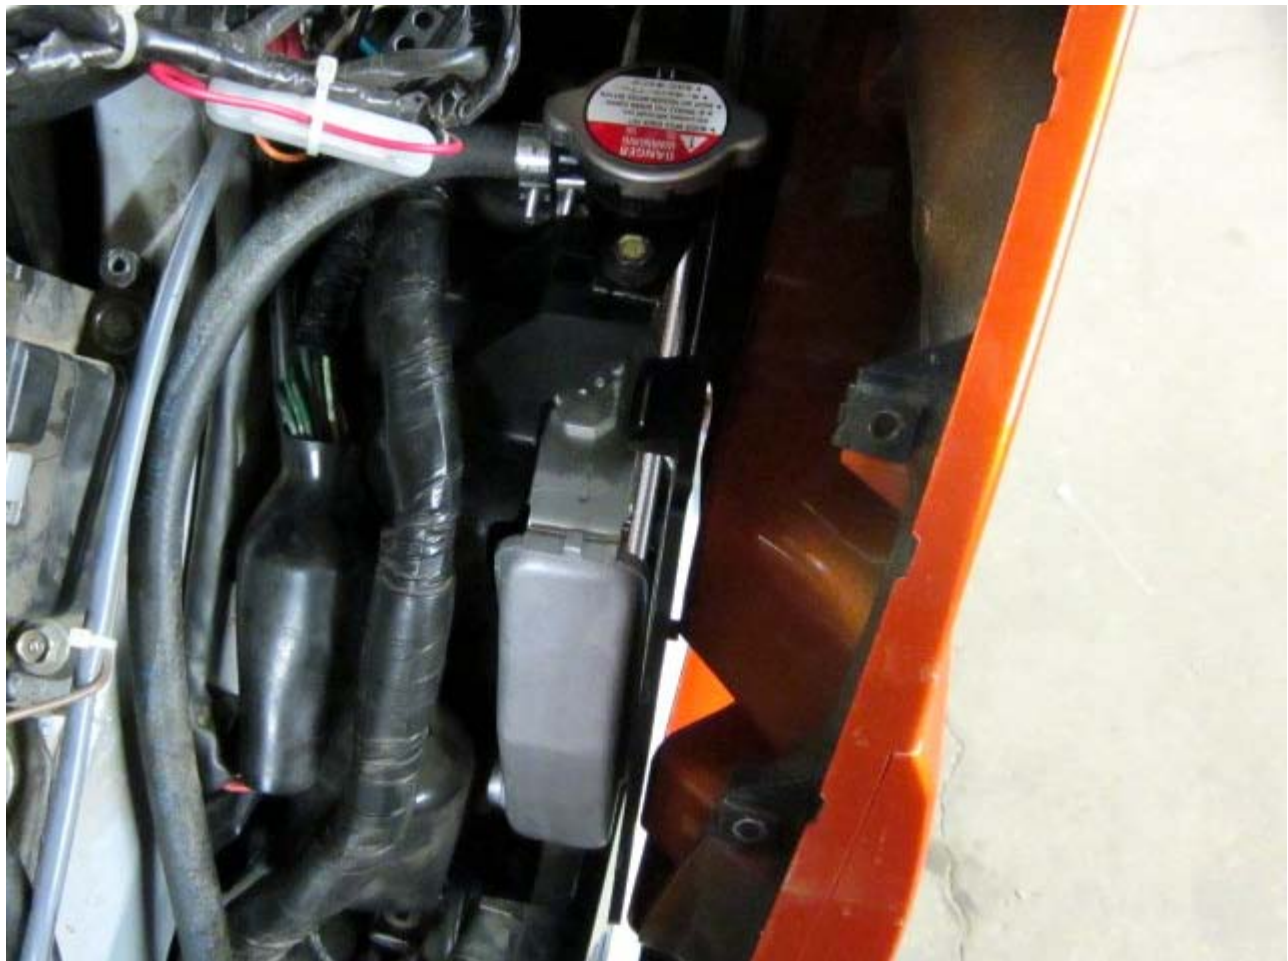
With the front fairing on there is plenty of room for the new radiators.

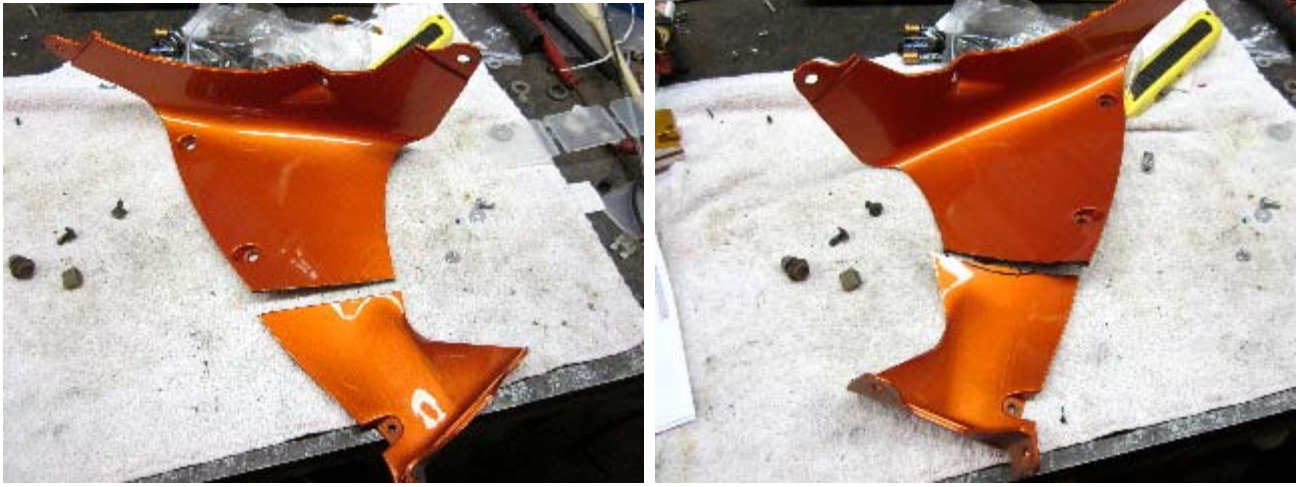
When I received all the frame pieces I was able to reassemble the bike, and I found a couple areas of conflict due to the larger radiators. The larger radiators pull the radiator hose upwards. This causes a fitment issue with the inner fairing covers. I could have bought the correct hoses but that would have been a pain to take the bike apart again and snake the hoses through the motor. Instead, I trimmed the covers. You can barely see them anyways.

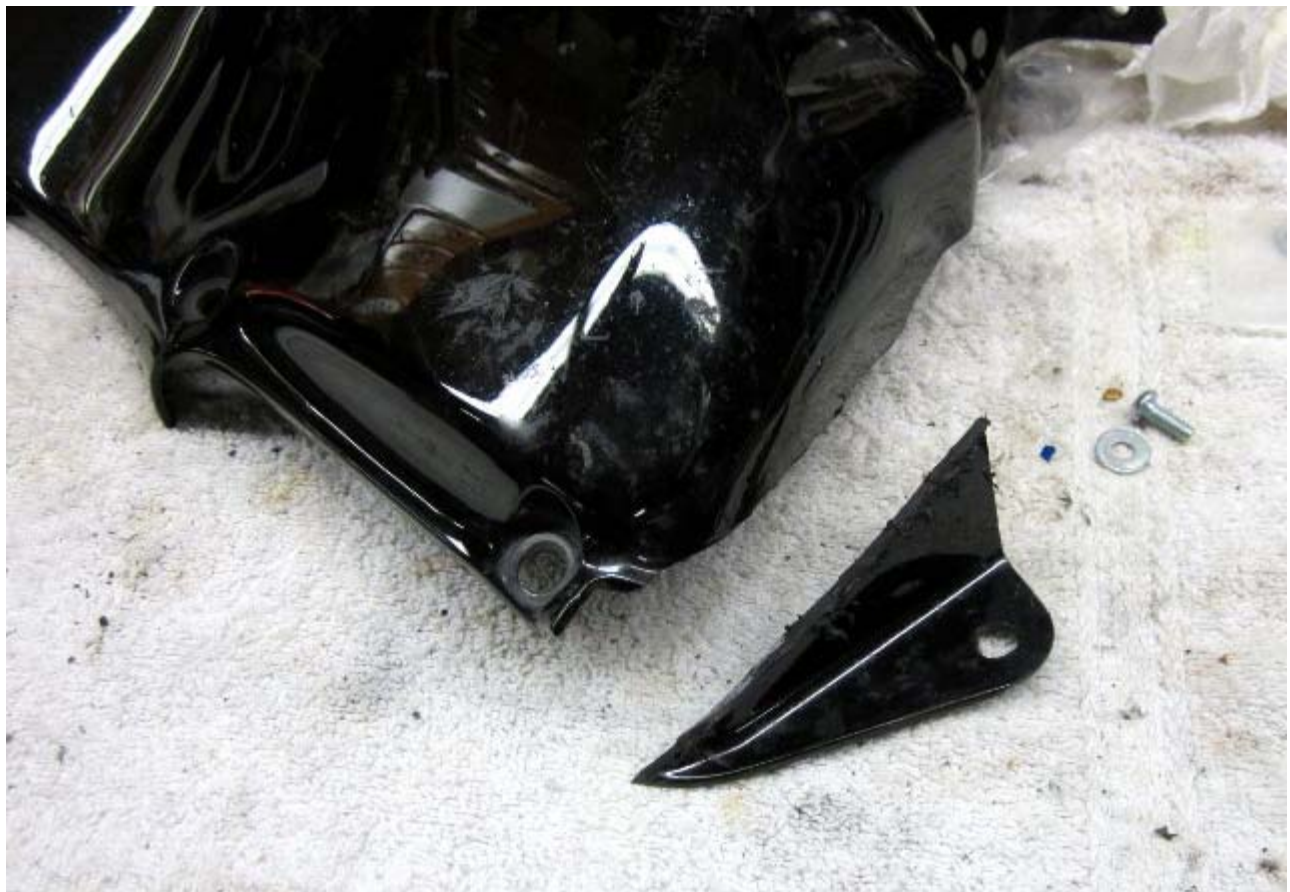
There was a similar issue with the black motor cover. Some trimming did

the job.

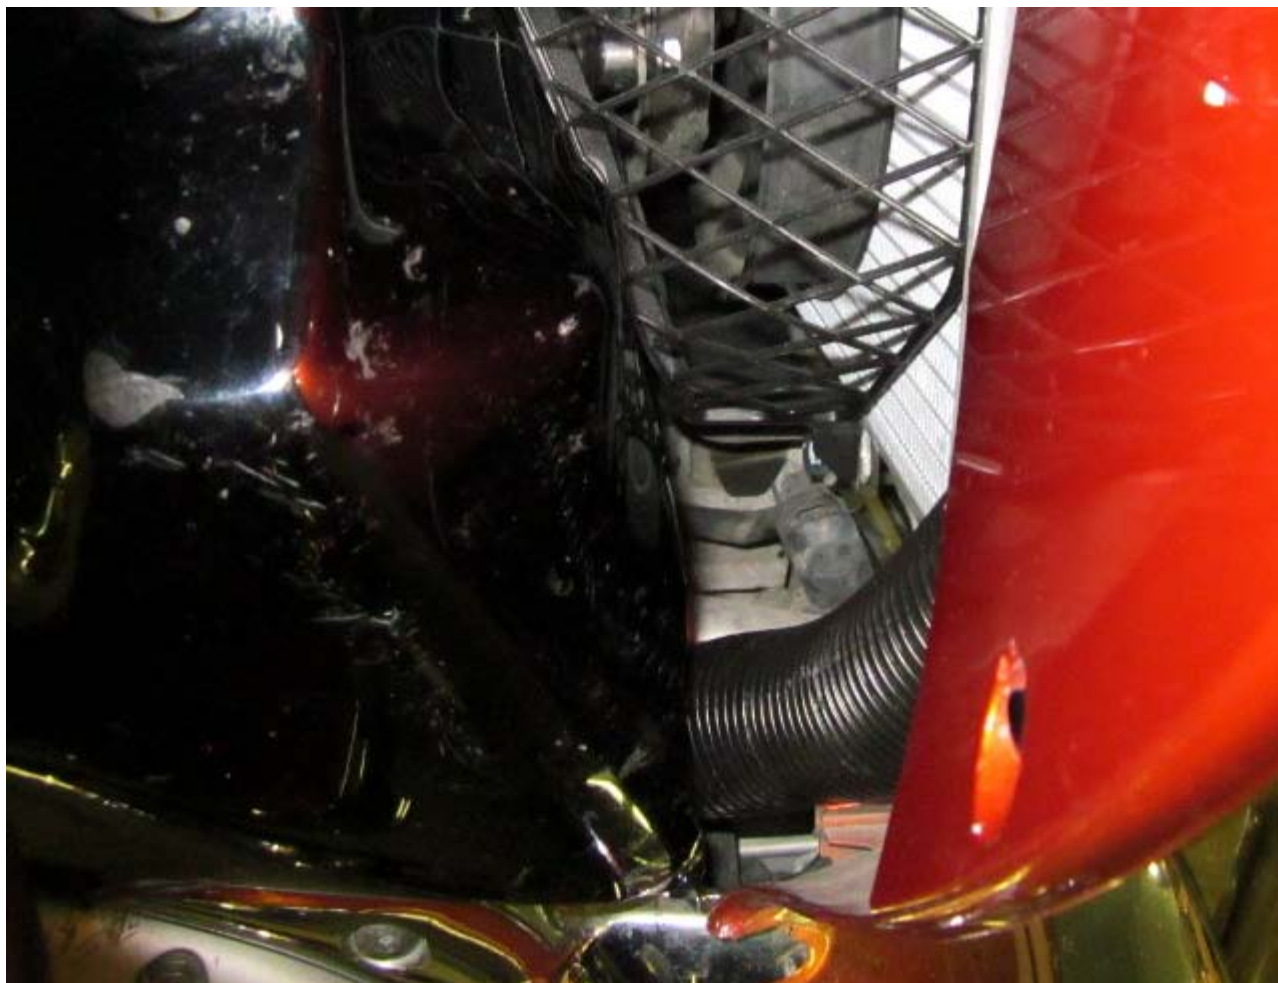
Here are both trimmed covers bolted in. Trimming the covers makes them ten times easier to install than normal. A section of the water hose was exposed so I put some ziploam over it. No one will ever notice this. The larger opening might let a little more air in.
