Radiator upgrade

While my bike was apart for repairs I decided to see if I could fit the larger 2006-later fans to my 2002. When I ordered Honda repair parts I also ordered larger radiators.

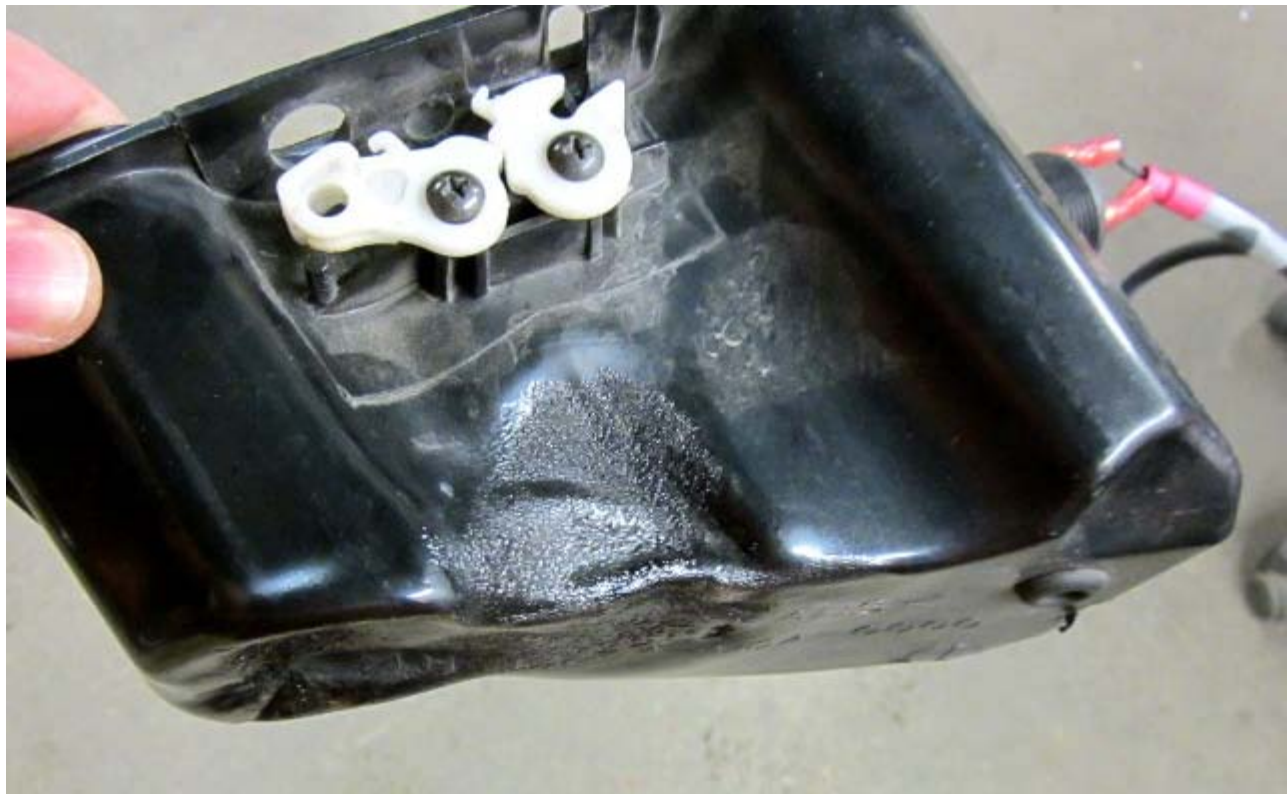
When I put the top shelter on the left storage pocket interfered with a cable bundle that was raised due the larger radiator. I used a heat gun to flatten the bottom for clearance.
